JNP GROUP
CONSULTING ENGINEERS

Rattle Road Cutting

Case Study

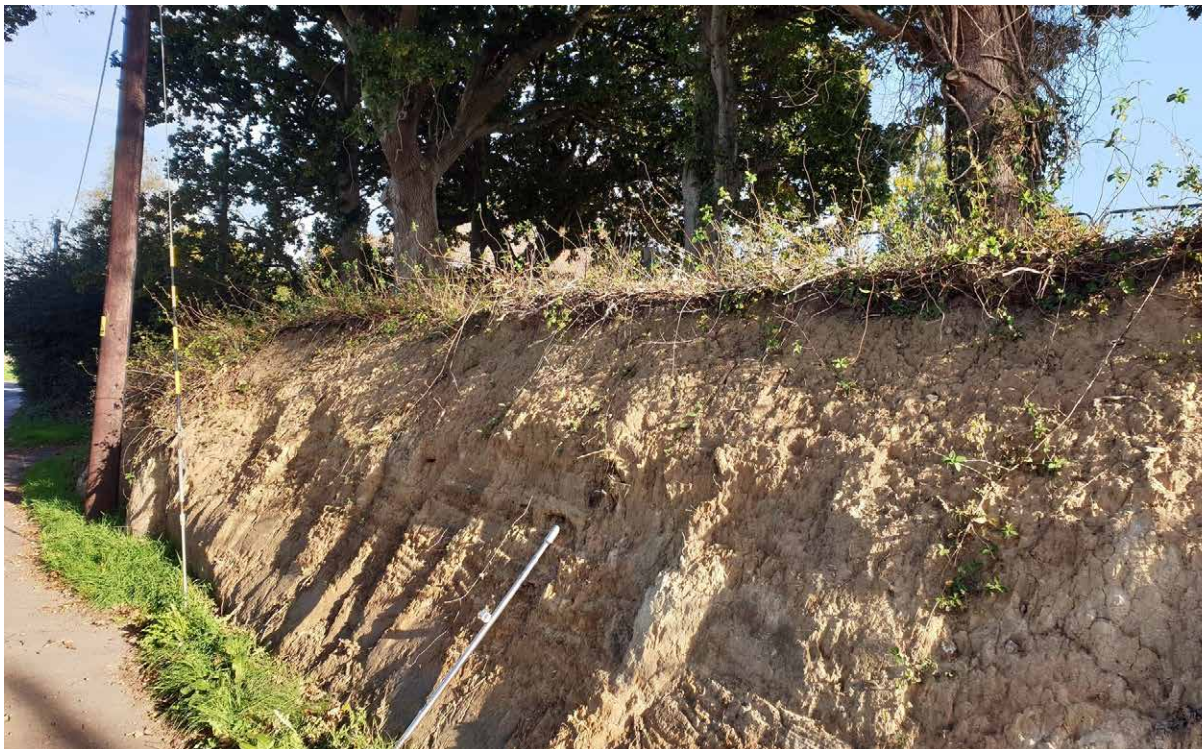
Cut slope faced ongoing deterioration creating stability issues.

- The site included mature trees with roots extending into the cut slope crest, posing a risk of root zone damage during the project.
- The cut slope faced ongoing deterioration with fines being washed out during heavy rain, creating stability issues.
- Limited working space and restricted site access required careful planning to avoid road closures and maintain operational traffic flow.
- The presence of existing utility services and telecom infrastructure presented tight constraints, as diverting these services was not a viable option.
- A constrained timeline required a rapid design finalisation process, as the Client and groundworks contractor were set to demobilize from the site.
- Complex slope gradients and varying requirements across sections demanded meticulous design coordination for clarity and effective execution on-site.

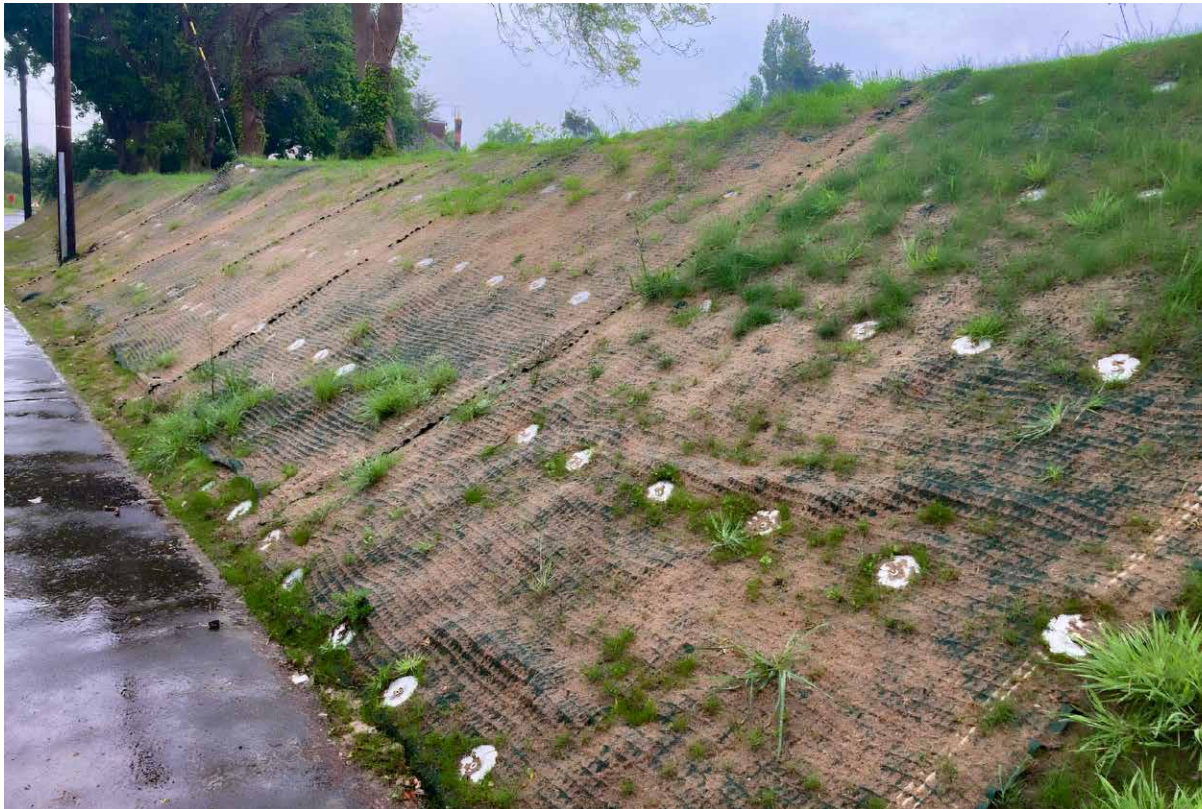
Soil stability ensured using Rootlok bags, benching, and hydroseeding.

A 'softer' engineered solution was used to protect mature trees and their root zones, with slope re-profiling designed to minimise disturbance and approved by an arboriculturalist. Residual soil issues were addressed with benching, Rootlok geotextile bags, and hydroseeding to stabilise slopes and prevent erosion.

- Slope re-profiling protected trees and roots
- Soil stability ensured using Rootlok bags, benching, and hydroseeding.
- Anchor solution reduced equipment needs and managed lane closures.
- Design adjusted for existing services with third-party coordination.
- Fast-tracked design and regular site visits ensured timely completion.
