Gresham Road Depot

Overview

Case Study

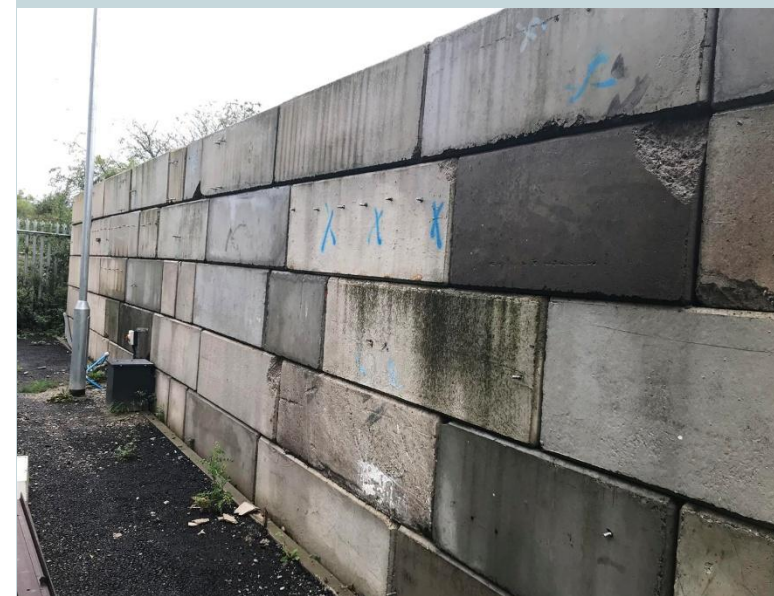
During the inspections, JNP Engineers took into consideration the stability of the side, intermediate and end walls of the waste bays that were constructed using 1800 mm long x 600 mm wide x 600 mm high BW600 concrete builder block units. These blocks were stacked/overlap bonded to form the bays of the required size and height.

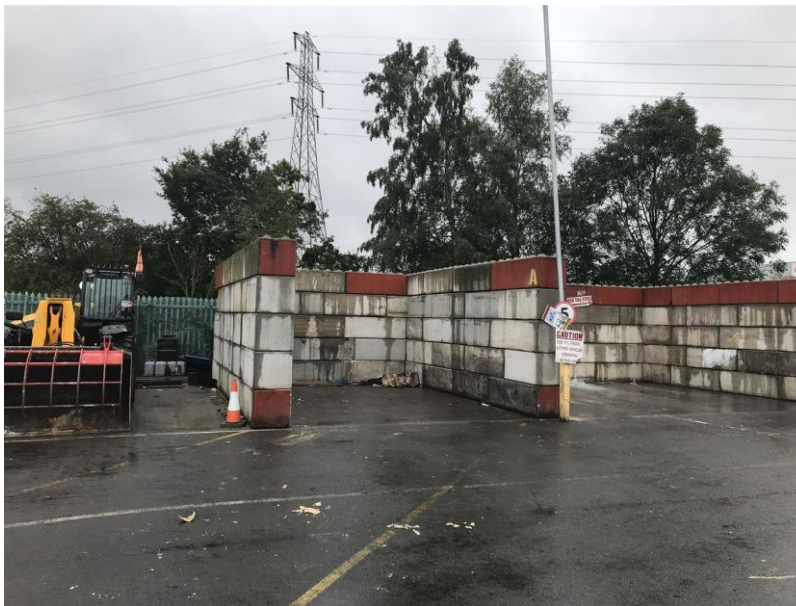
When inspecting the modular waste storage bays, JNP Engineers needed to gain a full understanding of how the walls were constructed, taking into account the limitations when in use at the waste depot. Factors that were taken into consideration included wall stability when used for the storage of household waste, the effects of accidental vehicle impact and safe pedestrian access to the inside as well as around the periphery of the storage area during the facility's operational hours.

As a result of the assessment, our Engineers provided recommendations in relation to the overall stability of the structure, additions to facilitate the operations of the loader machinery, the introduction of additional safety barriers and signage to enable pedestrians to safely move around the site. In addition to this, alternative safer working practices were recommended in and around the storage area, with specific focus on suitable ways to keep pedestrians segregated from vehicles and machinery.
